# San Fernando, California, Earthquake of February 9, 1971

LEONARD M. MURPHY  
*Scientific Coordinator*

*Volume I*

*Part B.* Buildings *continued*; Soils and Foundations

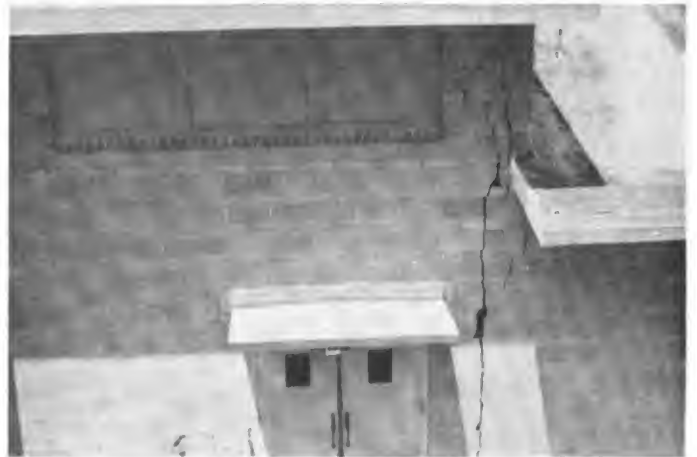
**Figure 7.**—Camp Karl Holton Juvenile Facilities. Recreation building. Wall crack at northeast corner of high roof area.

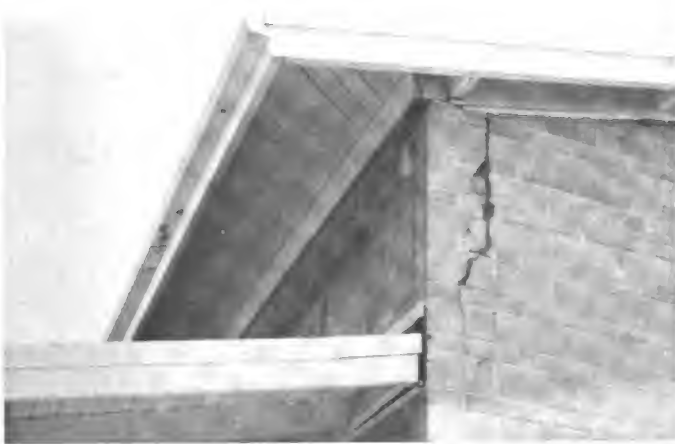
Figure 8.—Camp Karl Holton Juvenile Facilities. Recreation building. Wall cracking at southwest corner. Note separation between canopy and wall.

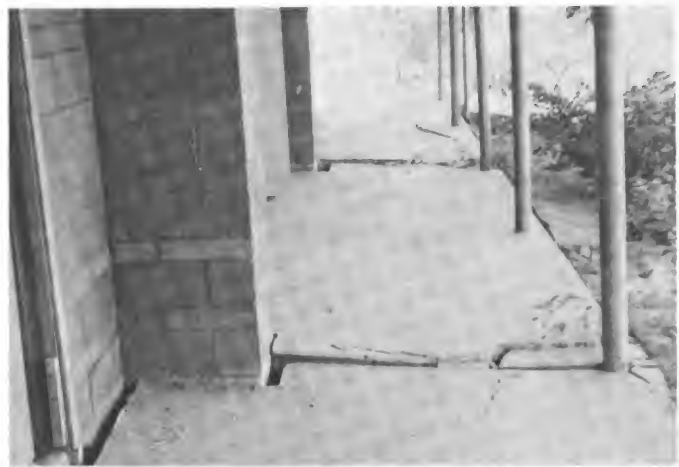
Figure 9.—Camp Karl Holton Juvenile Facilities. Recreation building. Sidewalk and ground rupture along west wall.

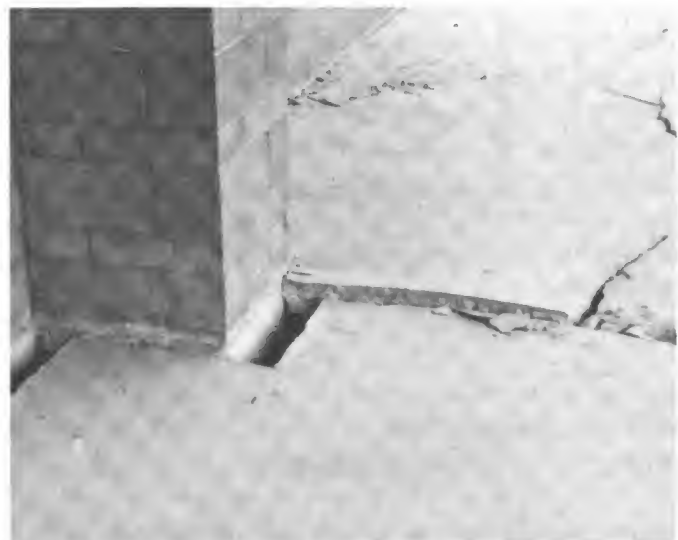
Figure 10.—Camp Karl Holton Juvenile Facilities. Recreation building. Sidewalk rupture at west wall.

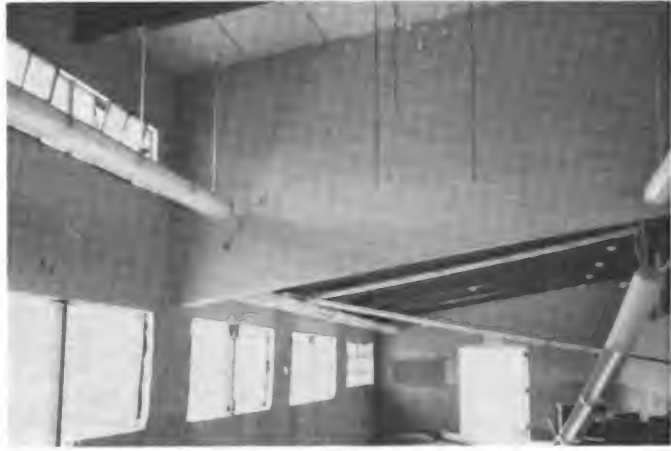
Figure 14.—Camp Karl Holton Juvenile Facilities. Dormitory building, south wall, west end. Concrete beam supporting upper wall and high roof.

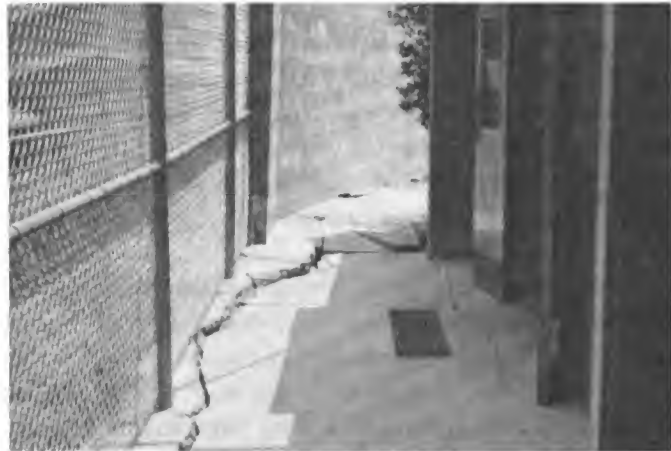
Ground movement and cracking were heavy at this location. Exterior sidewalks at the east end were cracked and dislocated (fig. 15). Ground fissures several inches wide occurred in the dirt driveway just

Figure 15.—Camp Karl Holton Juvenile Facilities. Dormitory building. Sidewalk ruptures at east end of building.

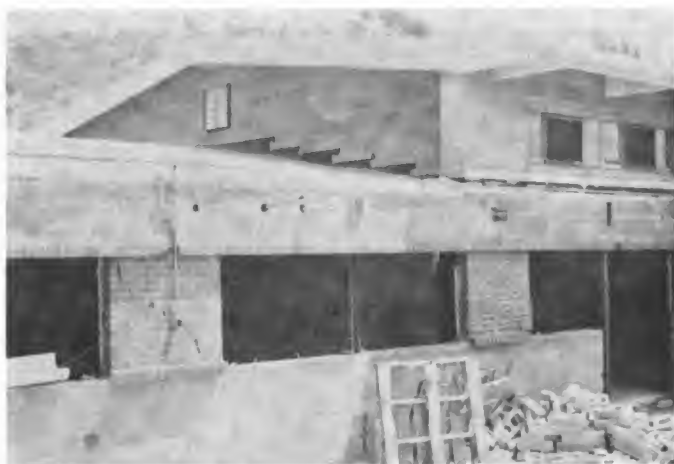
A new addition was under construction at the south-side wall at the west end. Several partially completed block walls were damaged by the earthquake.

Figure 16.—Camp Karl Holton Juvenile Facilities. Dormitory building, south wall, west end. Note building material on ground from partially completed additions.

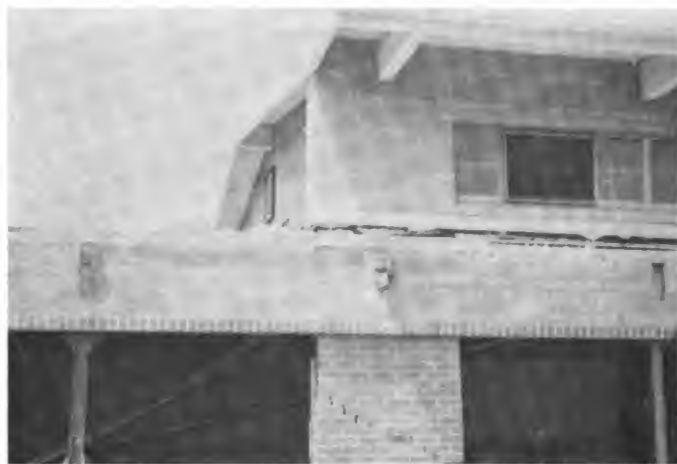
Figure 17.—Camp Karl Holton Juvenile Facilities. Dormitory building. Cracked wall piers in lower and upper piers, south wall.

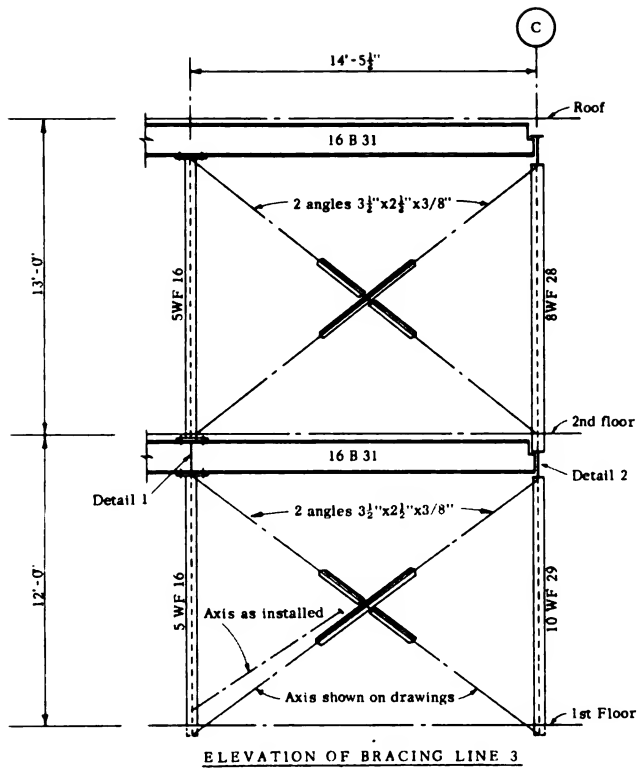
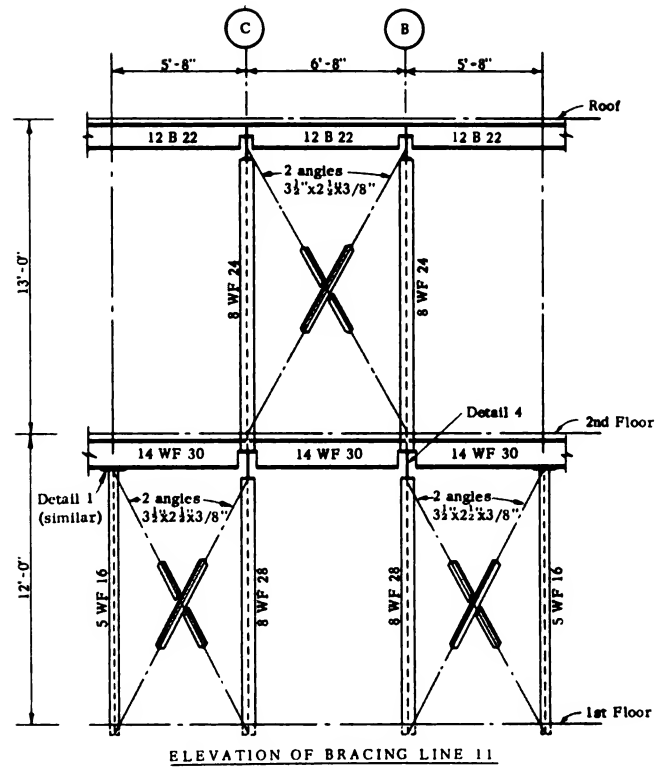
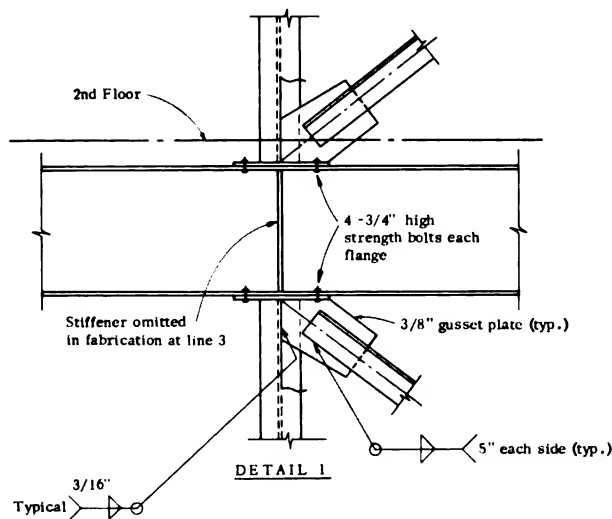
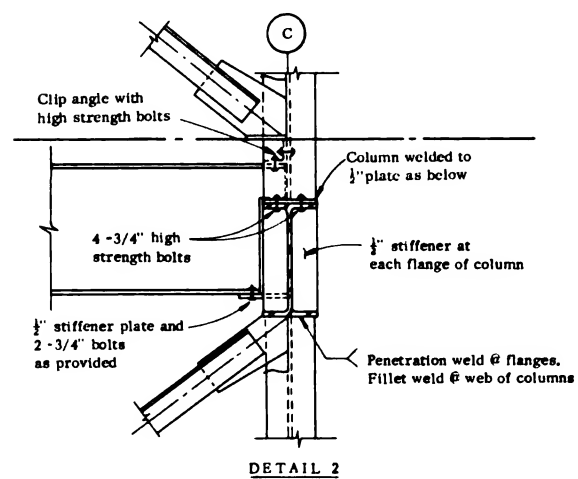
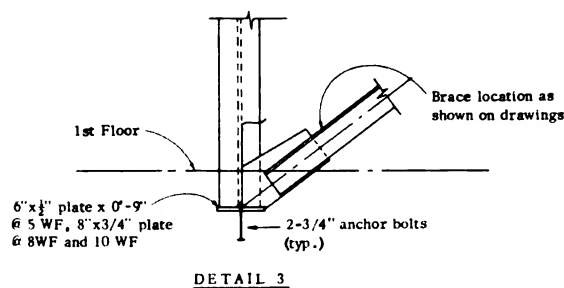
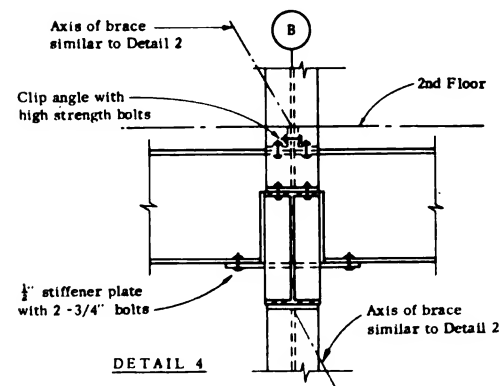
Figure 4.—Foothill Medical Center. Bracing elevations and details.

It is of interest to examine the design of the bracing system for the transverse lateral forces since its failure, which represents the major structural damage, permitted transverse movements resulting in glass and partition damage. Calculations based on the drawings and the 1962 Los Angeles City Building Code reveal the following results: The design forces to be taken by the bracing on line 3 would be approximately 63 kips at the roof and 80 kips at the second floor, resulting in a first-story shear of 143 kips on line 3. The diagonal braces have an  $l/r$  of about 190 to 200, based on overall length, or one-half that value if the diagonal in tension is assumed to brace the diagonal in compression. Building codes, design specifications, and authoritative text-

Uniform Building Code and about 114 kips under the 1970 Code. The shear capacity of the four  $\frac{3}{4}$ -inch round high-strength bolts in detail 1 of figure 4 is 52 kips with the one-third stress increase. A design force of 88 kips in the diagonal applied  $11\frac{1}{2}$  inches high on the 5WF16 column (fig. 5) would result in elastic stresses in the column over 200 kips per square inch, which is six times the yield stress. Overturning forces on line 3 resulting from the code level design forces would be 175 kips at the base neglecting frame interaction. The vertical dead load in the columns would be 50 kips or less. Two  $\frac{3}{4}$ -inch round anchor bolts were provided at each column base plate.

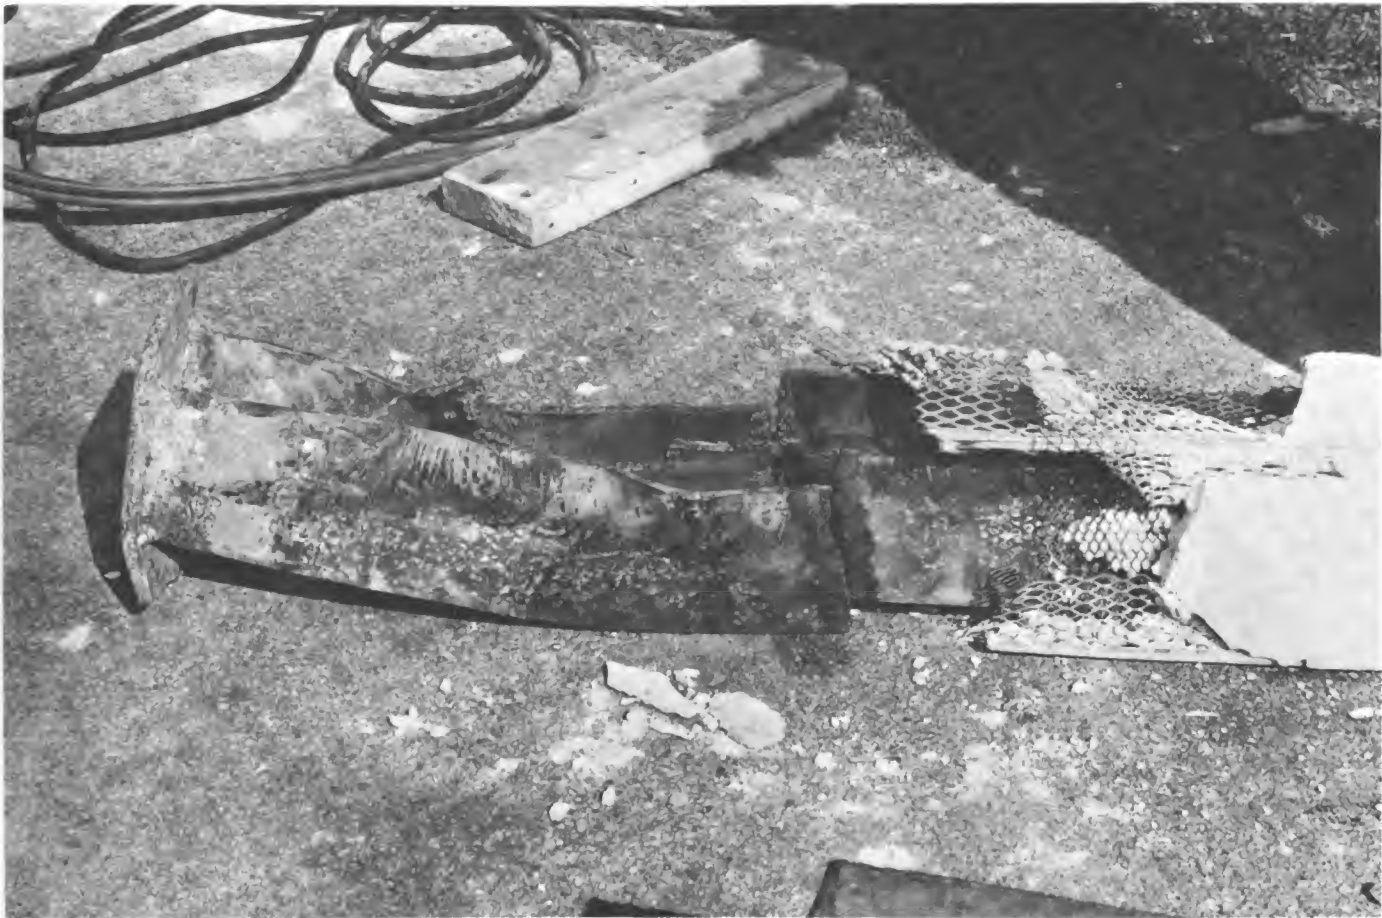
Figure 6.—Foothill Medical Center. Base of 5WF16 column on line 3 after being removed from structure. Gusset plate is up for reference. Los Angeles City Department of Building and Safety, John Shadle, photographer.

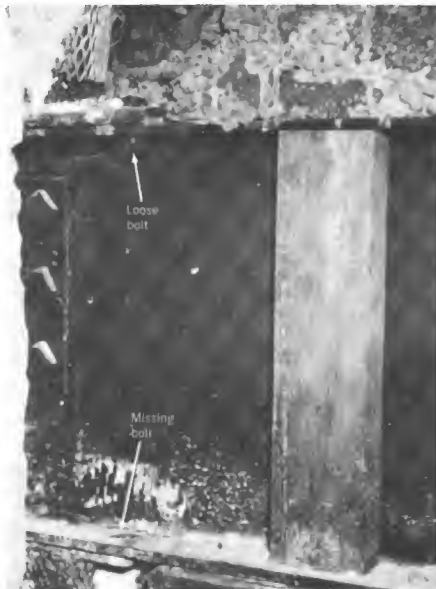
Figure 7.—Foothill Medical Center. Second-floor beam on line 3 with 5WF16 column and brace connections. Note missing bolt at lower flange and loose bolt at top flange. Loring A. Wyllie, Jr. photograph.

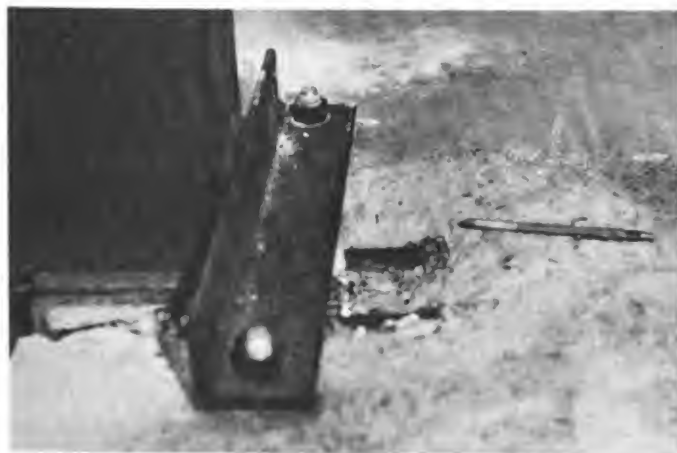
Figure 10.—Foothill Medical Center. Base of typical 6- by 10-inch structural tube column for exterior sun shade. Note spalled concrete and horizontal anchor bolts. Angle added after earthquake as a repair. Paul F. Fratessa photograph.

Repairs to the structure consisted of replacing the sheared bolts and installing an oversized gusset plate at the first floor to partially compensate for the eccentricity of the one diagonal on line 3. Figure 12 shows this connection as repaired and can be compared with figure 5. A new 5WF column was installed on line 3 to replace the badly distorted columns. Angles were installed to reanchor the exterior screen support columns as shown in figure 10. Plaster, ceiling, and stairway repairs also were required.

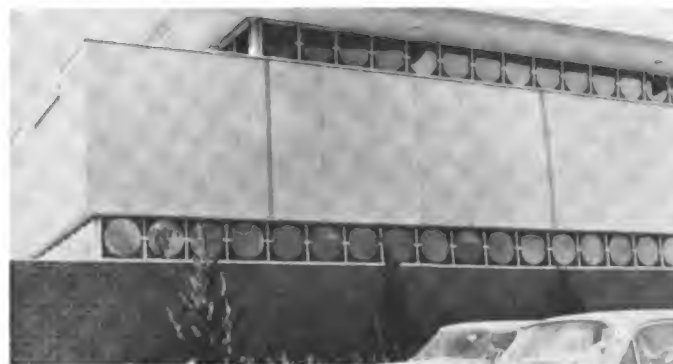
An initial examination of the exterior of the building led to the misleading conclusion that there was little or no structural damage. Figure 5, a photograph taken immediately after the earthquake, shows a few broken windows, but little else in the way of damage. It was reported that office equipment, desks, and filing cabinets moved across the second floor and, in some cases, tipped over. Some nonstructural damage was reported, such as buckling of the second floor T-bar ceiling, partition damage at the second floor, and spalling of the first-floor brick sills.

Figure 5.—Pacoima Lutheran Medical Center. Southwest corner, just after earthquake. Note two broken panes of glass at the second floor. Ralph Goers photograph.

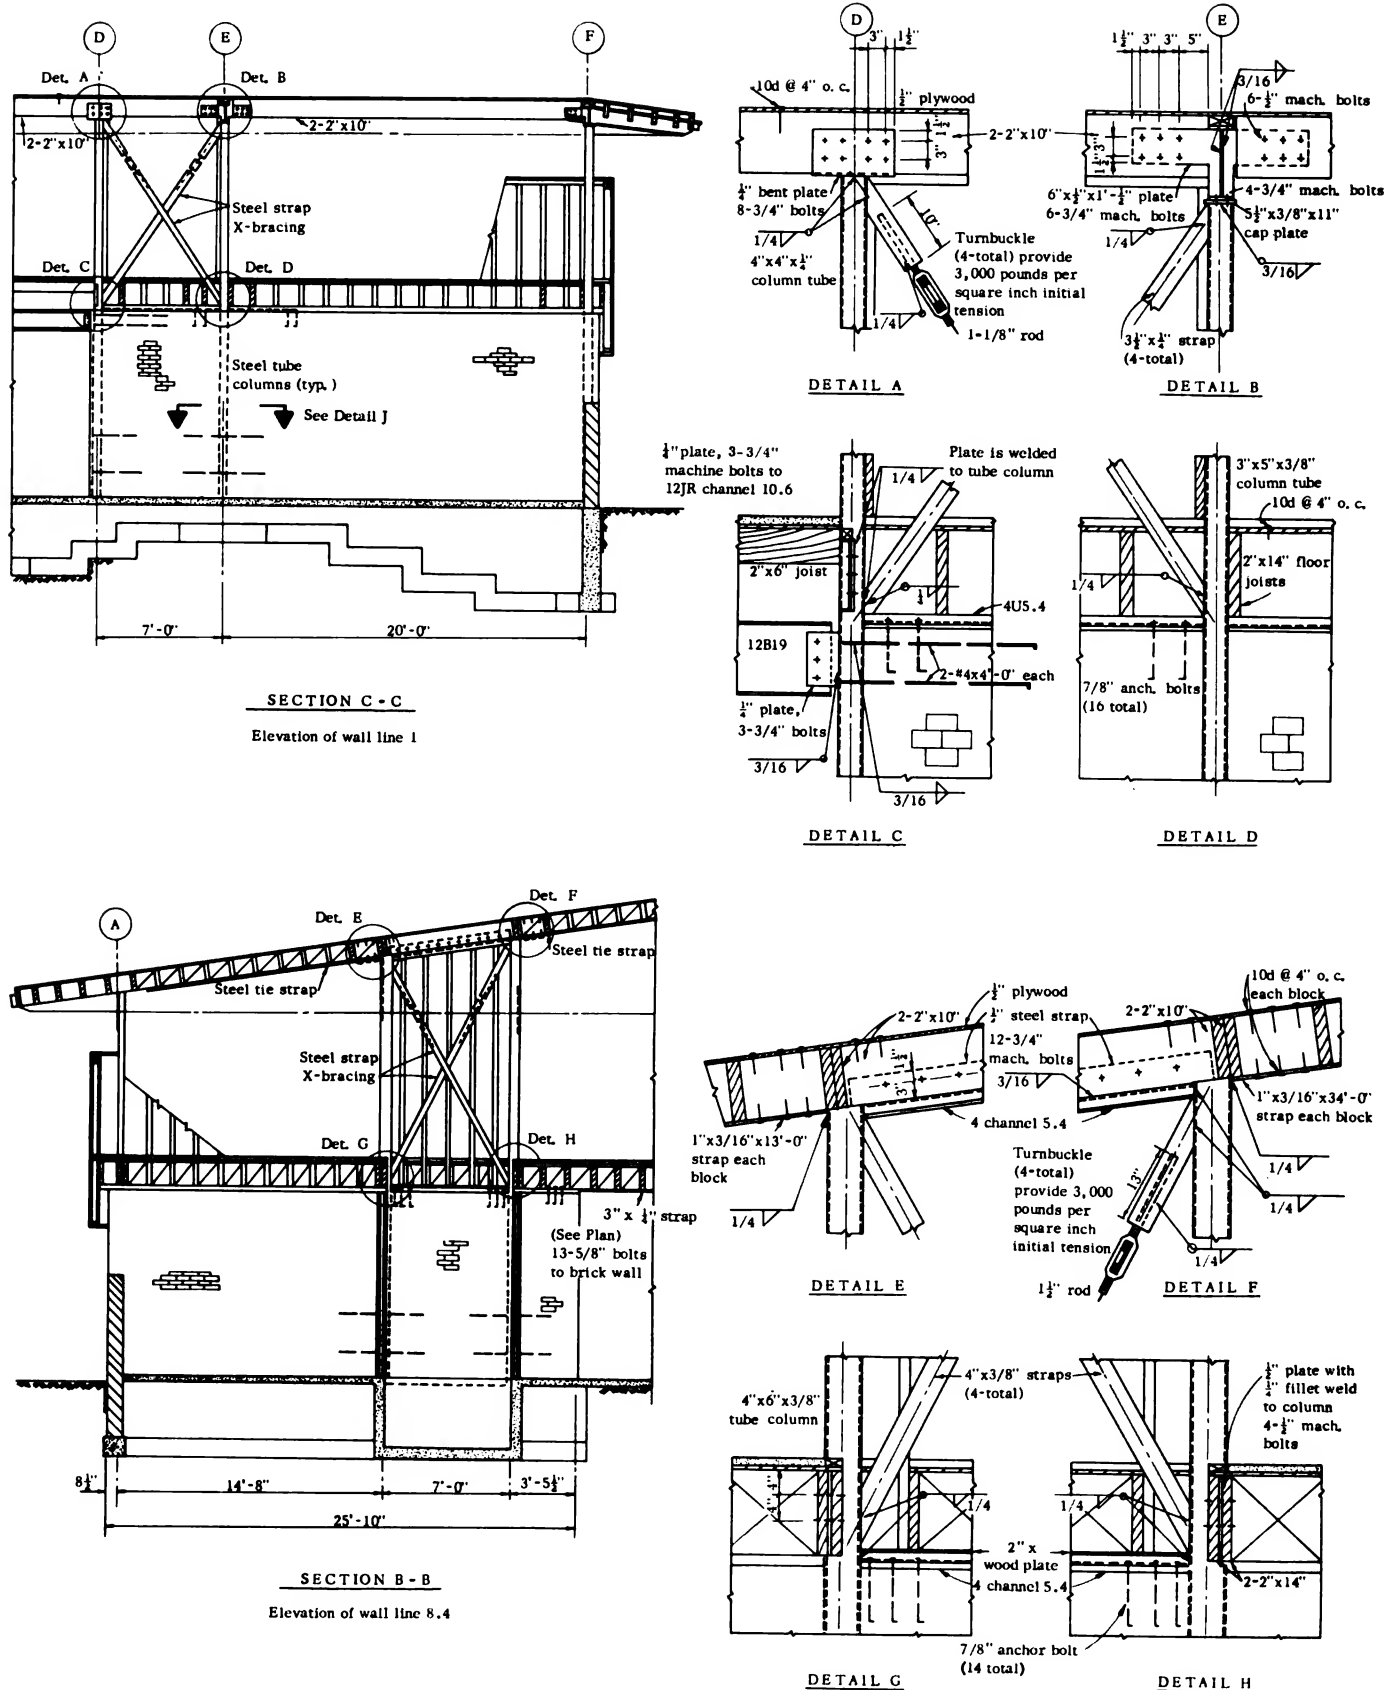
Figure 6.—Pacoima Lutheran Medical Center. Elevation of wall lines 1 and 8.4.

Although the building survived the earthquake with a relatively moderate amount of total damage, there was significant structural damage in several key areas. Probably the most significant occurred at the north-south shear walls on lines 1 and 8.4 (fig. 6).

At line 1, the double 2- by 10-inch roof collectors (fig. 6, details A and B) failed at the connections to the steel X-bracing system at lines E and D (fig. 7). The tube column at line E was bowed in the direc-

At line 8.4, several failures occurred in the collector system used to transfer the forces to the steel X-bracing. This system is as shown in figure 6, details E through H. The 1-inch by  $\frac{3}{16}$ -inch by 34-foot strap noted in detail F extends to the ridge and beyond, as shown on the roof plan and figure 6, detail K. The 4- by 10-inch wood ridge member was split

On line 1 (fig. 6), the X-bracing in the second story was replaced with a 15-foot-long grouted brick panel and a structural steel collector system at the roof. The cracked area in the first story was repaired by removing and replacing a 2-foot-wide band centered on the crack.

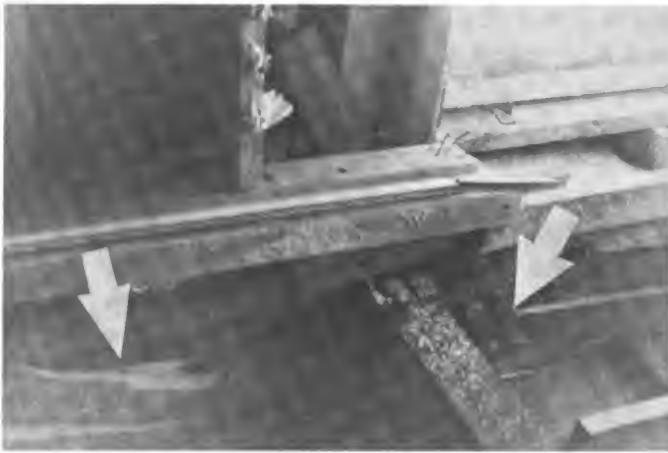
Figure 7.—Pacoima Lutheran Medical Center. Connection of steel bracing (line 1) to timber ties at roof on line E. Arrows point to splitting of 2- by 10-inch ties on each side of column. Ralph Goers photograph.

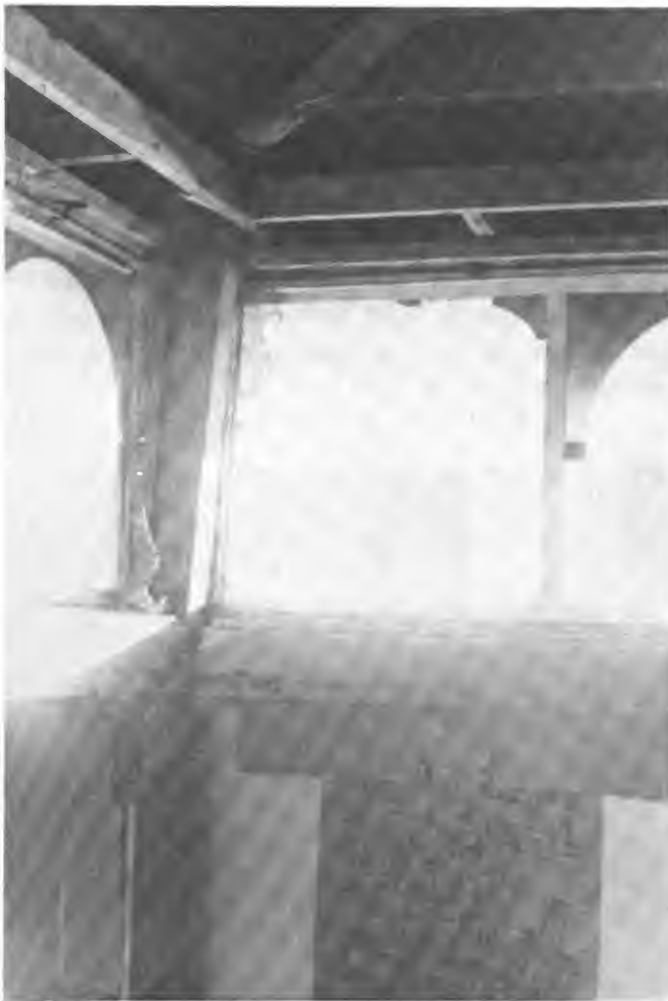
tion parallel to the wall. The corner column at line F also yielded in bending, as shown in figure 8. It is evident that these columns acted as cantilevers above the window sill, probably after the buckling failure of the steel plate X-braces. In figure 6, detail B, there is considerable eccentricity involved in the transfer of shear from the roof diaphragm into the X-bracing system. The resulting moment must be transferred through the straps and bolts to the double 2- by 10-inch wood members. It is evident that this contributed to the shattering of the wood members, which was probably followed by the buckling on the X-braces and the bending yield of the columns. Plywood roof sheathing above this connection buckled, causing roof failure (fig. 9). Below the second floor, the grouted brick wall cracked (fig. 10) where the tube column at line E was embedded in the wall (fig. 4, detail J).

Figure 8.—Pacoima Lutheran Medical Center. Column F-1, second floor, looking south. Ralph Goers photograph.

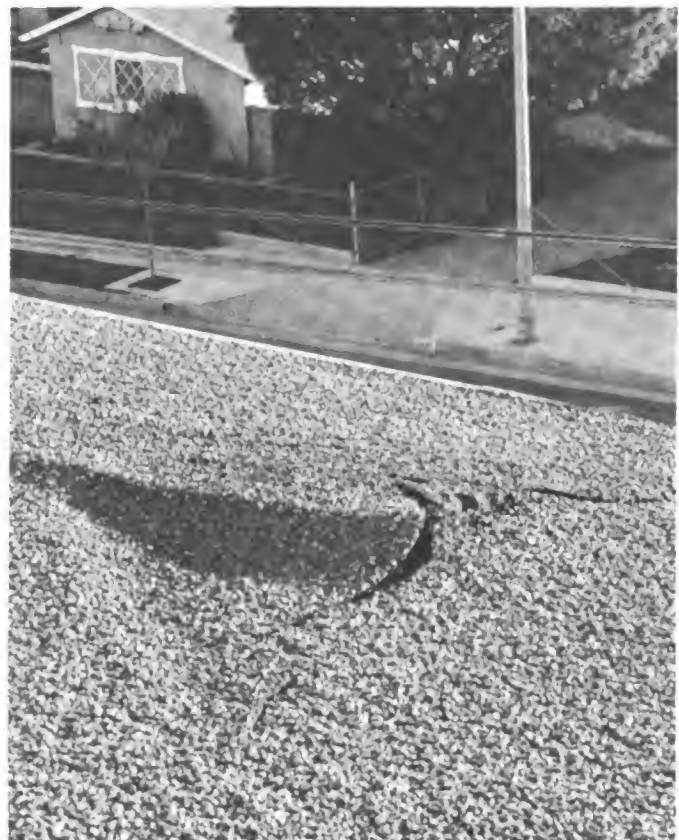
Figure 9.—Pacoima Lutheran Medical Center. Break in roofing at plywood failure at southwest corner immediately above detail B (fig. 6). Ralph Goers photograph.

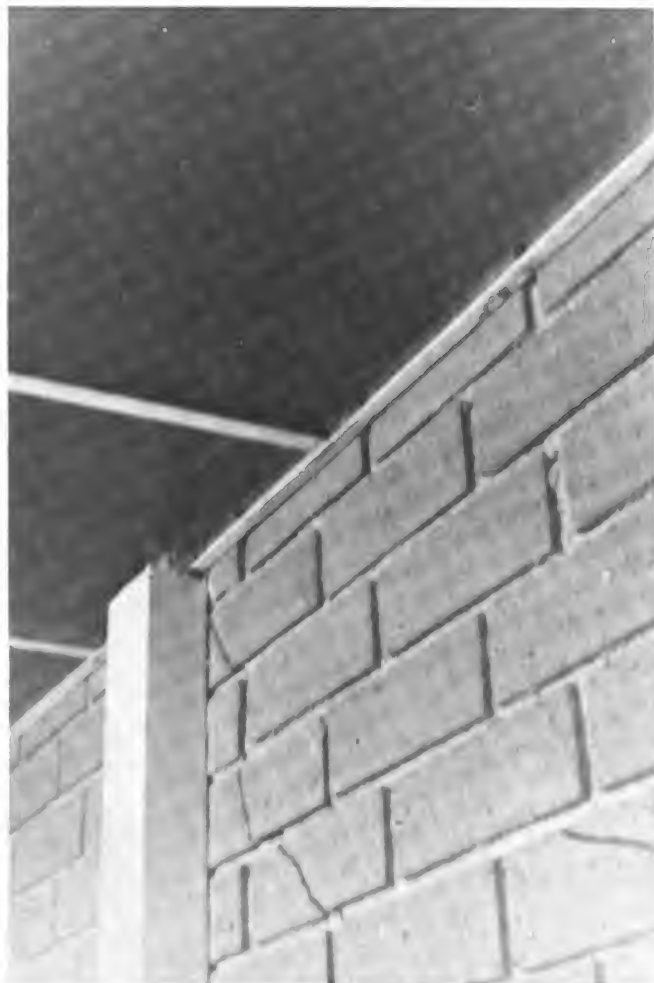
Figure 10.—Pacoima Lutheran Medical Center. Grouted brick wall at first floor, line E, from inside. Note diagonal crack in brick. Ralph Goers photograph.

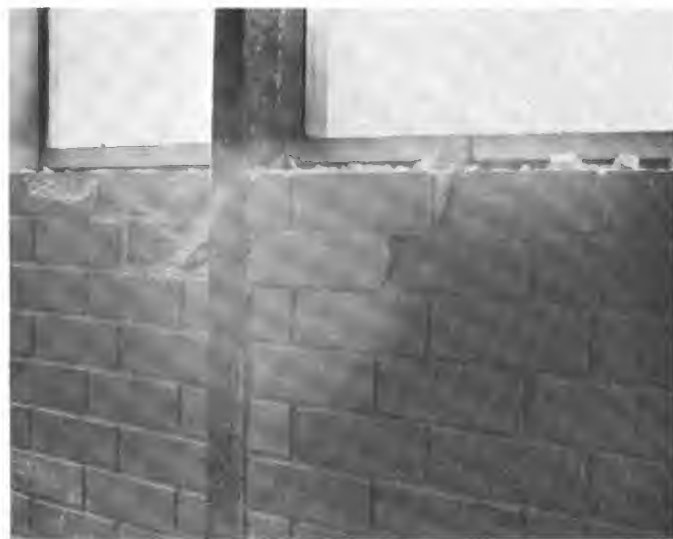
There were several areas of damage in the walls themselves. In addition to the previously discussed cracking at column E-1, there was some spalling of the brick at the top of the first-story sill wall owing to the cantilever action of the embedded steel tube columns (fig. 11).

Figure 11.—Pacoima Lutheran Medical Center. Grouted brick wall at first floor structural tube column. Note spalled concrete at top of wall. Ralph Goers photograph.

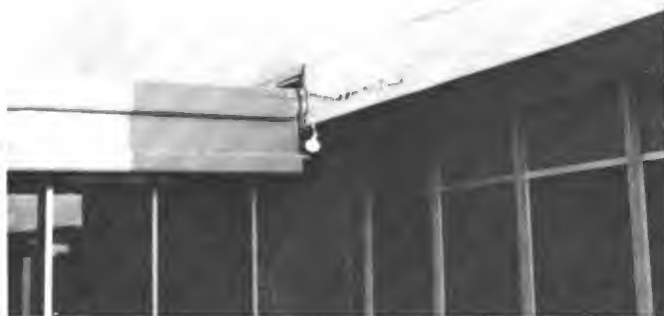
Figure 4.—Golden State Community Mental Health Center. Canopy roof over passage to main hospital. Vertical offset at joint is  $5\frac{1}{2}$  inches. Paul Fratessa photograph.

The most obvious damage occurred where the low roof over the passage abutted the main hospital building. Although there was no structural connection, the joint was flashed. Figure 4 shows a vertical offset of about  $5\frac{1}{2}$  inches, as well as some horizontal offset and evidence of pounding damage. The slab on grade immediately below also was offset vertically at the juncture of the two buildings. At line 13, where the canopy connects to the Mental Health Center, there was some minor spalling, but no evidence was found of flexural cracks in the canopy spandrels or slab.

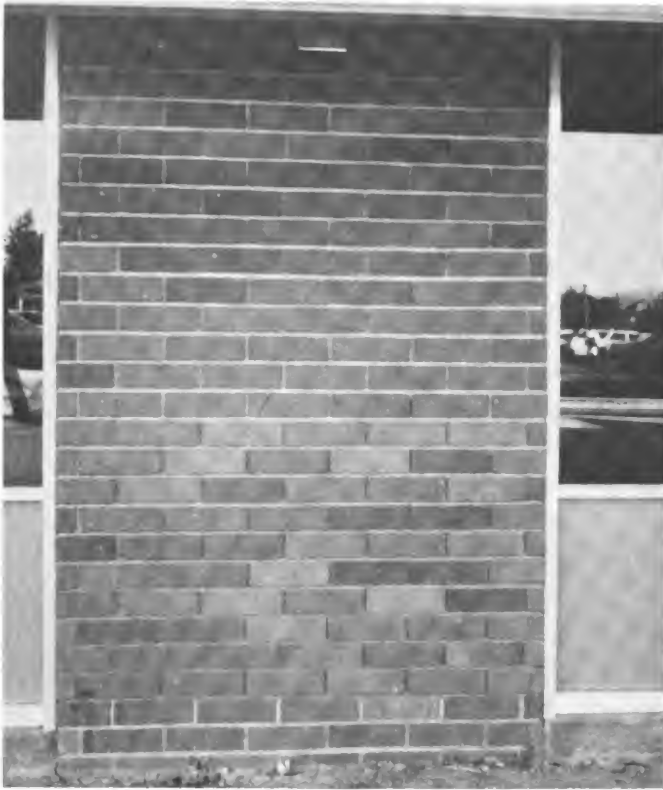
Figure 5 is a photograph of the first-story (above-grade) brick pier at column line 6 in the west wall (line B). It will be noticed that the diagonal cracks appear in one direction only. The second-story pier immediately above this one also was cracked in the same direction. South is to the right in this figure.

*Figure 5.—Golden State Community Mental Health Center. Cracked grouted brick wall on line B at line 6, looking east. Thomas Wasser photograph.*

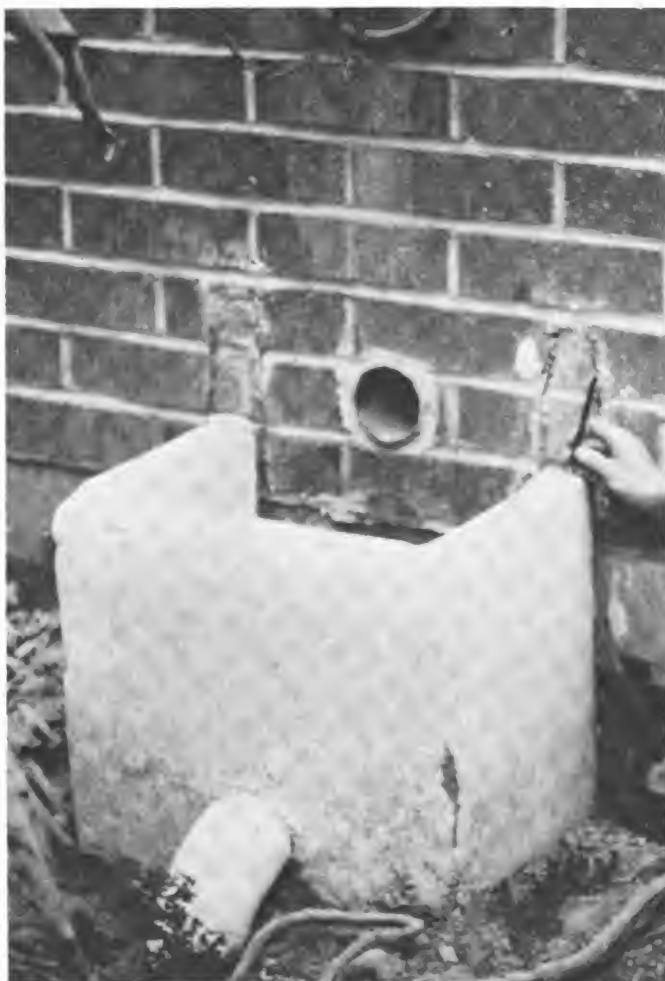
Figure 7.—Pacoima Memorial Lutheran Hospital. Vertical offset between catch basin and wall at brick wall 12 feet 11 inches west of line 7. Paul Fratessa photograph.

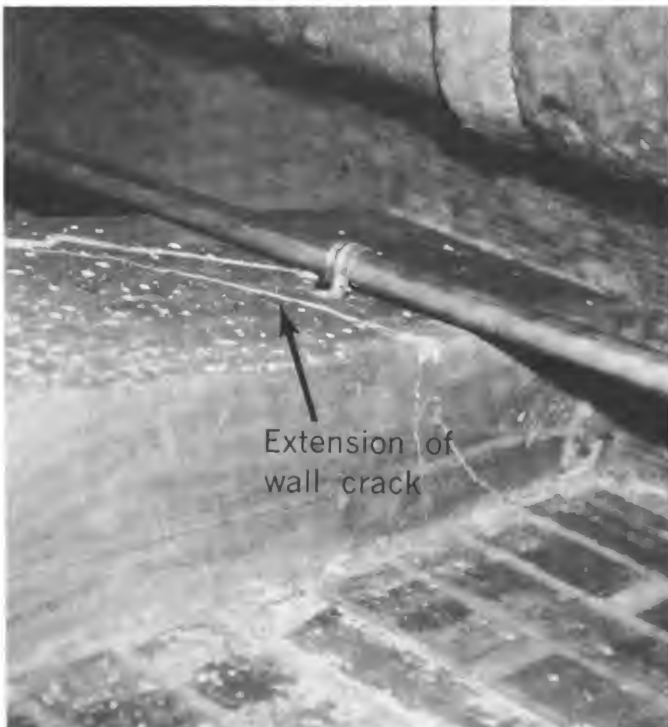
The only observed damage to this unit was the diagonal crack through the west brick wall (fig. 9). This crack extends through the concrete column, as shown in figure 10. There was evidence of pounding between the roof of this unit and the nursing wing second-level floor. Figure 11 shows the north end of the roof beam. The light substance at the expansion joint is Styrofoam joint material which has been forced out of the joint by compression. There was some damage to the flashing at the expansion joint. The concrete block walls and plaster partitions of this unit were virtually undamaged.

Figure 10.—Pacoima Memorial Lutheran Hospital. Concrete column at brick wall on line 1x at line H. Crack through column is an extension of wall crack shown in figure 9. Loring A. Wyllie, Jr. photograph.

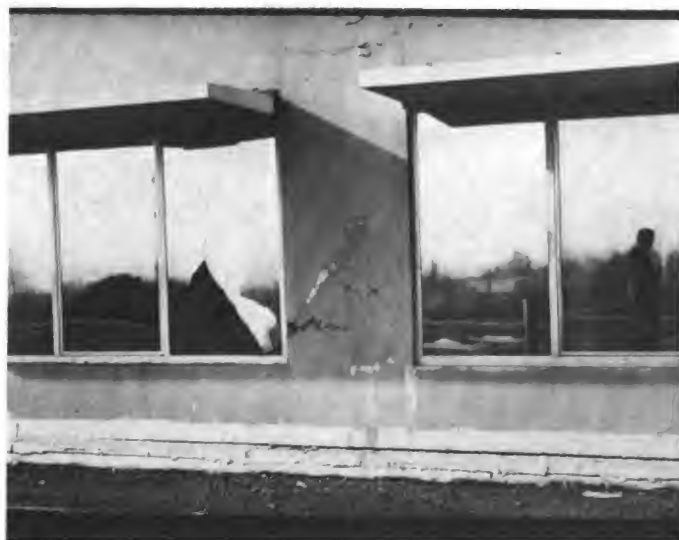
Figure 12.—Pacoima Memorial Lutheran Hospital. Pier on line G at line 10 looking north. Loring A. Wyllie, Jr. photograph.

The south wall suffered concrete cracking at the second-level column, just west of line 11 as shown in figure 12. Other than this, no significant cracks were observed in this wall. No cracking or damage was observed on the north wall (fig. 2) except for several broken windows.

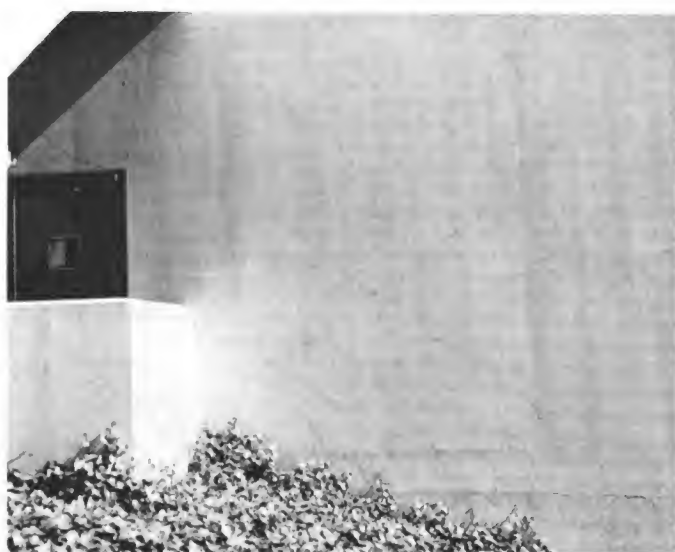
Figure 13.—Pacoima Memorial Lutheran Hospital. Shear wall at line 1, second level. Paul Fratessa photograph.

second level, but fewer similar cracks at the third level. Cracking was evident at the construction joints. The spandrel over the second-level door was cracked as shown in figure 15. Although it cannot be seen in figure 13, several of the diagonal cracks at the second level extend in a straight line through the third-floor construction joints and into the third-level wall. The wall below the second floor showed some diagonal cracks, which were smaller in number and size than those shown above the second floor.

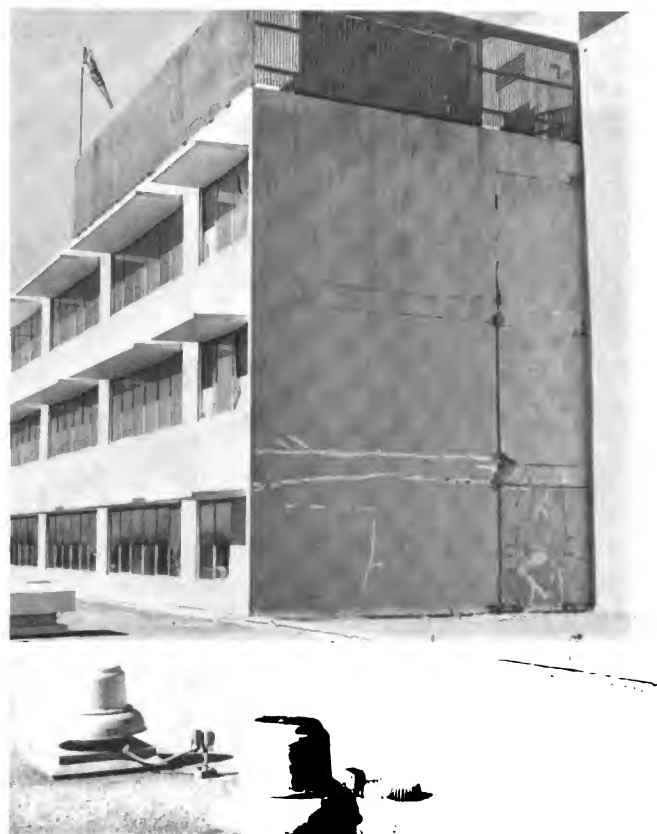
The shear wall at the second level and above on line 11 (fig. 5) was cracked severely as shown in figures 14 and 15. The diagonal cracks of the wall extend through the construction joints at the floors. All construction joints showed movement. The knockout panels for future construction showed movement. The white patches seen in figure 14 evidently were made before the earthquake. The thin piers adjacent to the stairwell and to the north of the knockout panel were shattered at the second level, as shown in

Figure 14.—Pacoima Memorial Lutheran Hospital. Elevation of shear wall on line 11. Patching of concrete prior to earthquake is visible. Note knockout panels at right side of wall. Paul Fratessa photograph.

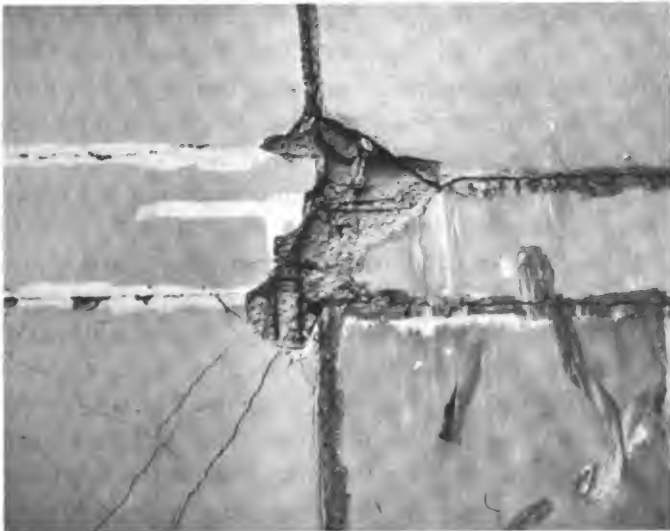
Figure 15.—Pacoima Memorial Lutheran Hospital. Closeup of damaged joint at knockout panel at third floor, line 11. Paul Fratessa photograph.

The damage pattern shown in photographs (figs. 14 and 15) clearly indicates this action, which is not specifically provided for in codes and was not anticipated in this structure.

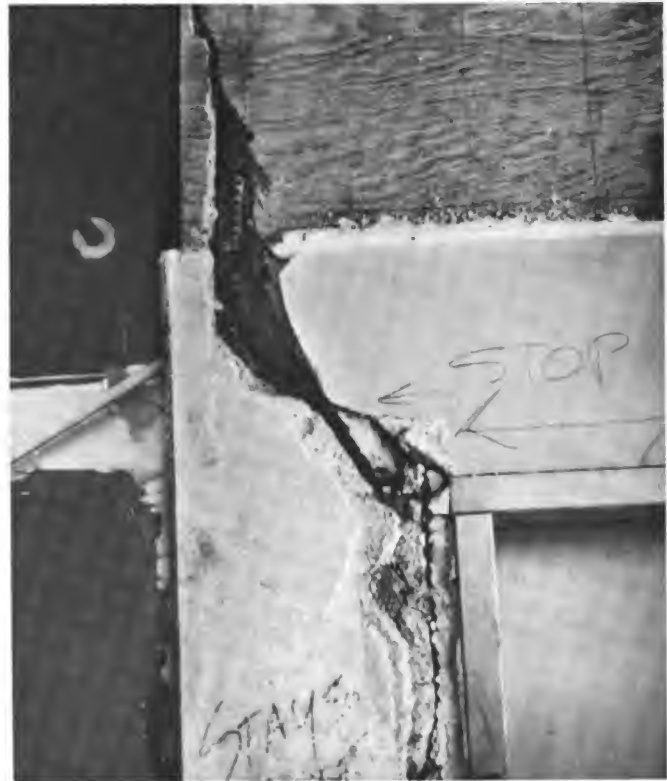
figures 16 and 17. There was virtually no damage to this wall below the second floor.

Figure 16.—Pacoima Memorial Lutheran Hospital. Pier on line 11 at second floor, adjacent to large opening between lines E and F, looking east. Paul Fratessa photograph.

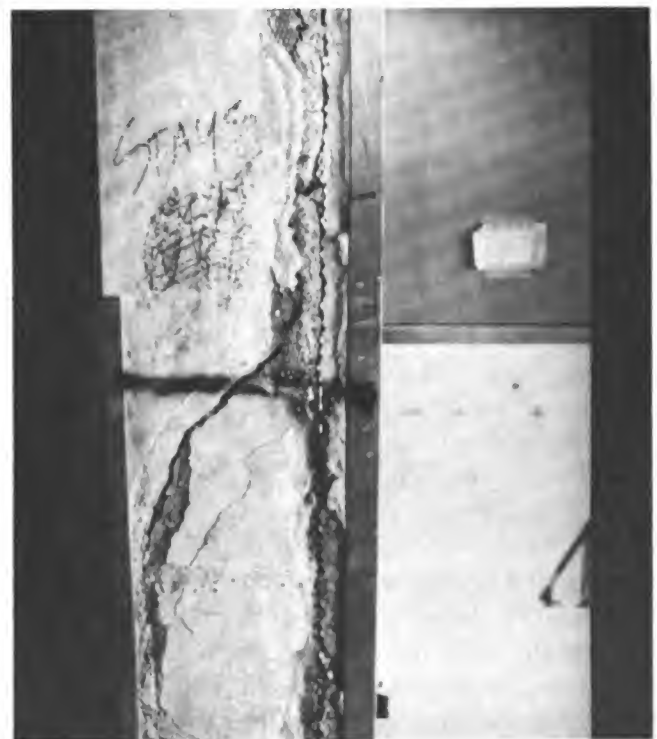
Figure 17.—Pacoima Memorial Lutheran Hospital. Thin pier on line 11 at second floor, adjacent to stair opening, looking east. Paul Fratessa photograph.

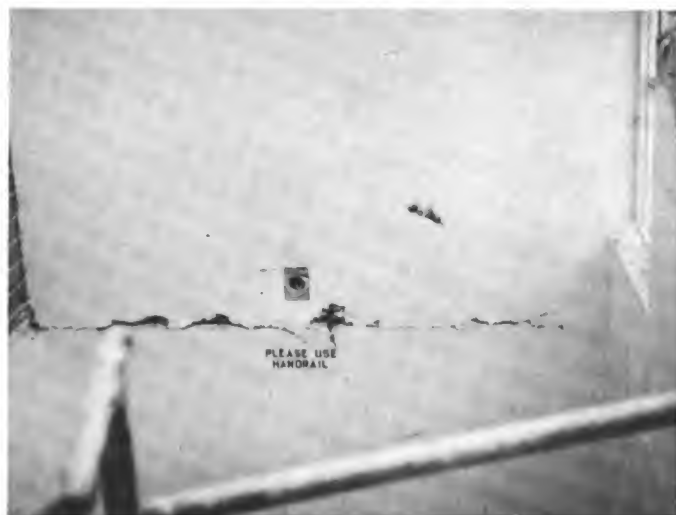
The concrete stair wall at the east end of stair No. 1 (fig. 3) was cracked badly. The worst cracks were located at the horizontal construction joints shown in figure 18. Stair landing beams were damaged. The grouted brick north wall of this stair had several diagonal cracks at the second level. The south concrete walls were not damaged. The east-end wall on line 17 was undamaged.

Figure 18.—Pacoima Memorial Lutheran Hospital. East wall of stair No. 1. Horizontal movement is at second-floor construction joint. Paul Fratessa photograph.

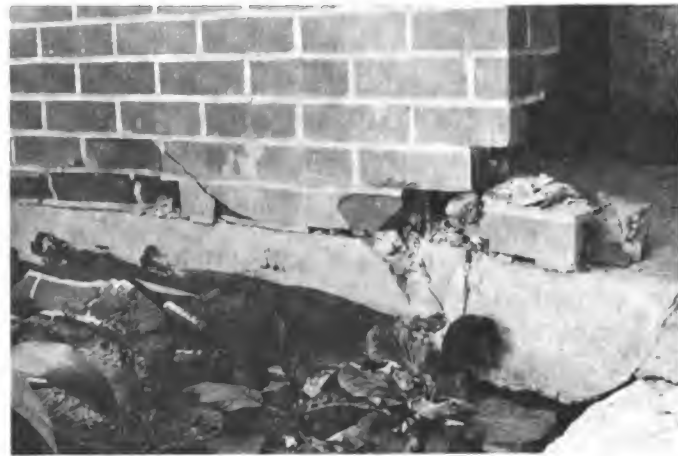
The second level, where the main entrance is located, was damaged very severely. The floor slab at the entrance (near B-7) was cracked (fig. 8). The grouted brick shear wall between lines A and B, 12 feet 11 inches west of line 7, shattered along the base and moved about  $\frac{1}{2}$  inch to the south (fig. 19). The concrete wall north of the entrance (line B near line 7) suffered small diagonal cracks throughout. The concrete wall on line D at the west end of the unit was not damaged. The interior concrete block walls at the stairs and electrical closet near lines B and 7 were shattered badly. When these walls were removed, it was found that there were no dowels from slab to block wall as are customarily used. The concrete column at A-7 (fig. 20) and the adjoining two columns to the east were cracked. Evidently, this was due to north-south motion. The concrete at the column at C-7 was spalled badly. No damage was observed at other columns. The grouted brick shear wall 6 feet 1 inch east of line 15 was not damaged.

Figure 19.—Pacoima Memorial Lutheran Hospital. Grouted brick wall 12 feet 11 inches west of line 7, looking east. J. F. Meehan photograph.

psi, while the 1970 UBC would allow a maximum of 100 psi. Although it had only minimum reinforcing, there were no signs of diagonal cracking. However, since there were no shear keys from the brick to concrete the wall moved as a unit on the concrete. The only mechanical connection was the No. 4 dowels at 30 inches on center to resist a shear of 3,000 pounds per lineal foot. Once this most rigid element failed, the western end of the building could move north and south and cause secondary cracking of the columns, concrete block walls, and the interior partitions.

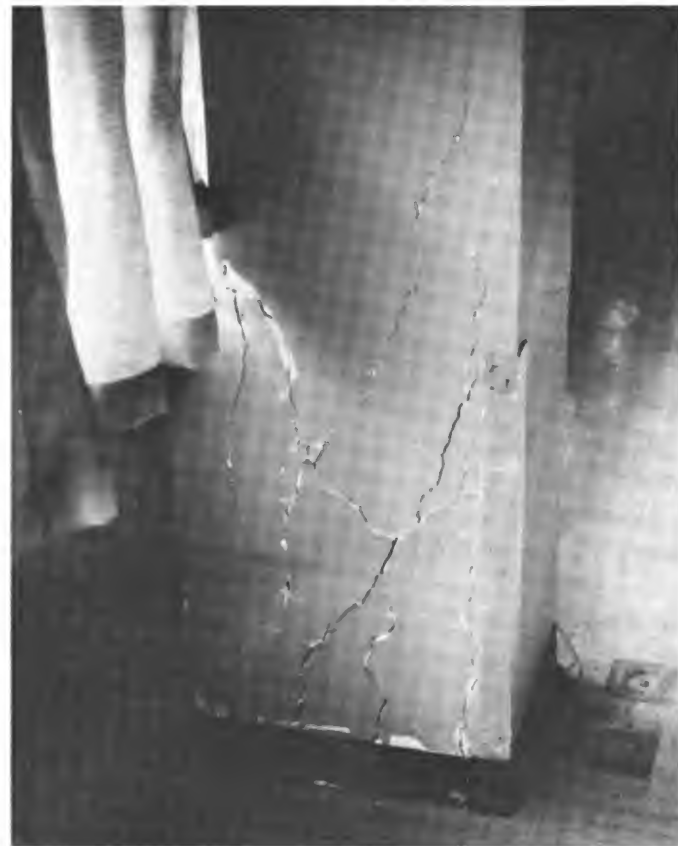
Figure 20.—Pacoima Memorial Lutheran Hospital. Column A-7 above second level; cracking is in plaster. Cracks in concrete were in same pattern. Paul Fratessa photograph.

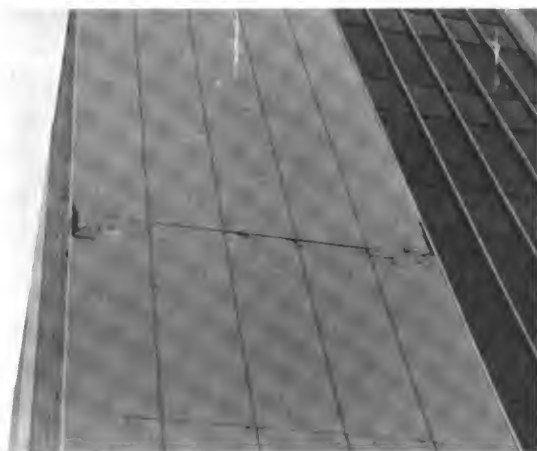
Figure 10.—Indian Hills Medical Center.  
North-side shear wall, east end.

Some of the shear walls were damaged by cracks at the horizontal construction joints at floorlines (figs. 10 and 11). There is evidence of slight horizontal movement. These cracks are not related directly to shear as a measure of diagonal tension. The slab depth is 6½ inches thick, and, in some cases, cracks occurred at the top and bottom of this intrusion of 3,000 psi lightweight concrete into the higher strength rock concrete of the shear walls proper.

The ends of the shear walls were designed as columns and were subjected to shear and axial load stresses. Concrete in the splice area crumbled (fig. 11). All of the shear walls in the lower levels cracked in the typical X-pattern (figs. 10 through 14), indicating high shear stresses.

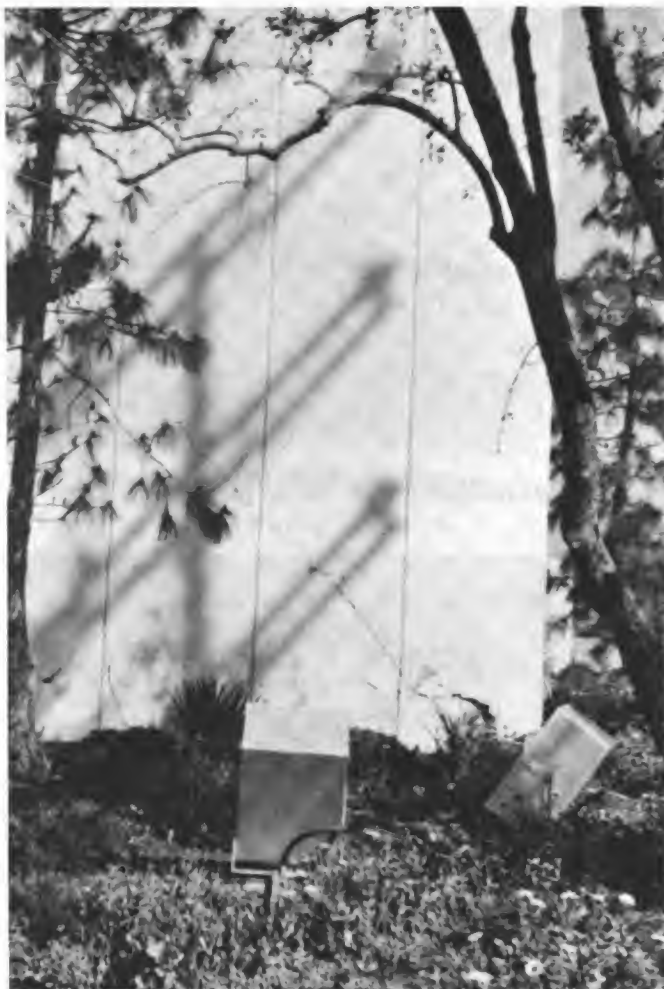
Figure 12.—Indian Hills Medical Center.  
South-side shear wall, east end.
